POWER2009-81018

INSPECTING U-TUBE BUNDLES USING ACOUSTIC PULSE REFLECTOMETRY

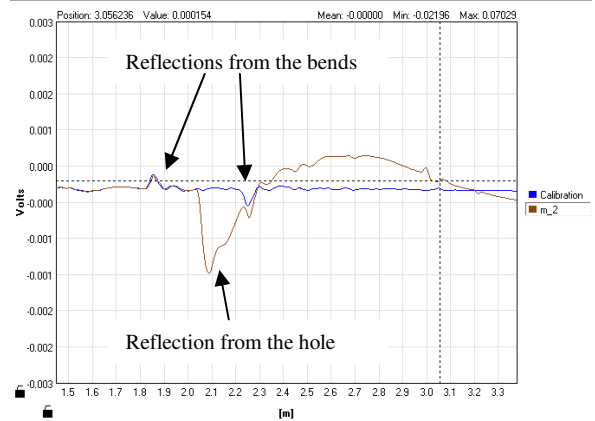
Figure 5: Measurement of u-tube with a hole in the middle of the bend, on top of a measurement from a blank tube.

Figure 5 shows two measurements: one from a blank u-tube with no faults, and one from a u-tube with a hole in the middle of the bend. Both tubes have 1" Outer diameter with a wall thickness of 2mm. hole diameter was 1.5mm.

The reflection from the hole stands out clearly and is easily distinguishable from the small reflections pointed out earlier, created at the beginning and the end of the bend. In fact the reflection from the hole is simply superimposed on these.

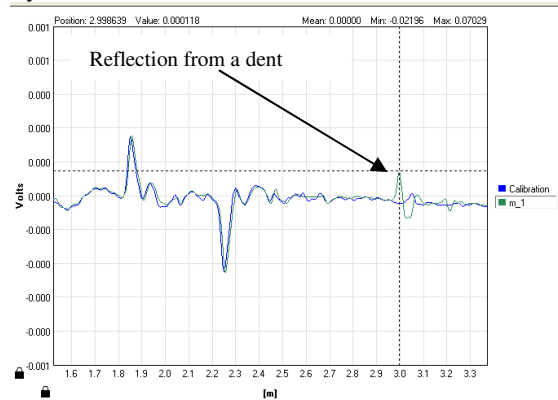
Figure 6: Measurement of u-tube with a dent on the leg beyond the bend, on top of a measurement from a blank tube.

Figure 6 shows two measurements also on tubes of similar dimensions. One measurement was taken from a blank tube, and the second was taken from a tube with a very small dent on the leg beyond the u-bend.

The reflections from the bends coincide in both tubes, whereas the dent stands out clearly in the faulty tube. These two examples demonstrate that the u-bend presents no obstacle to detection of faults, in the bend itself or beyond it.

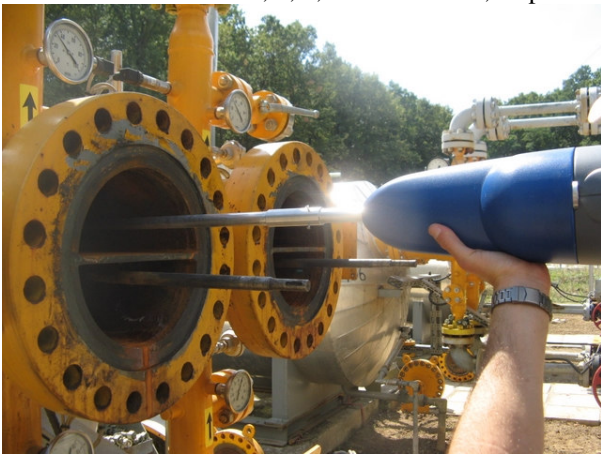
Figure 7 – the probe with the extension tube, inserted into one of the bundles.

exchangers, each of them containing two bundles of 39 u-tubes. Each tube was about 6.2 meters in length, with some variation due to different lengths of u-bends. One challenge in inspecting these bundles was that the tube sheet was deeply recessed with respect to the access port, requiring an extension of approximately 80cm to be fitted to the probe. A photo of the setup is shown in figure 7. A horizontal plate separating the upper and lower half of the bundle can also be seen in the photo. The map of a single bundle is shown in figure 8 – the rows in this bundle contain 5, 6, 9, 10 and 9 tubes, respectively.

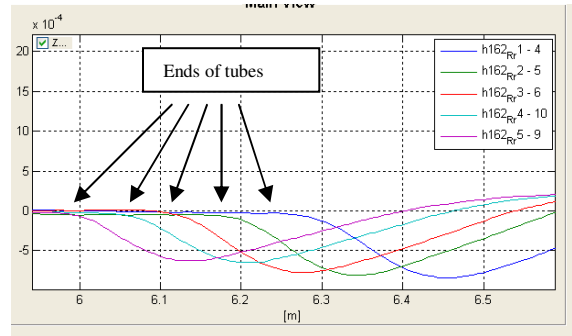
Figure 9 – reflections from the end of five tubes from five different rows.

All tubes found in a single row were identical in these bundles. Examining five representative measurements from the five different rows demonstrates the different lengths of tubes found in each row. In figure 9 we show a zoomed view on the reflections from the ends of the tubes. These occur at 6 meters in the shortest row (bottom row in figure 8) and 6.3 meters in the longest row (top row in figure 8).

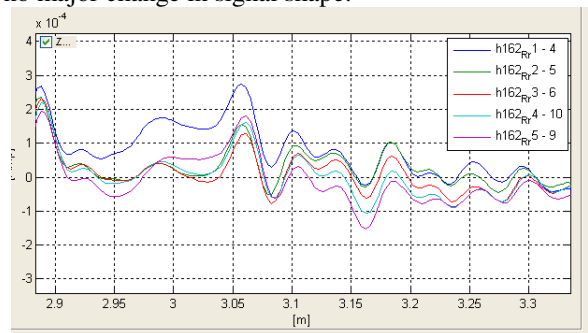
Figure 10 – signals near the centers of the same five tubes as in figure 9

The main difficulty at this site was in obtaining a good seal between the probe extension tube and the tube being inspected. Maneuvering the end of long extension tube and holding it properly against the tube sheet proved to be challenging, especially since some of the tube ends suffered from severe corrosion, which make a good seal more difficult to obtain. Lack of a good seal causes a certain amount of drift in the measurements, which is analyzed and removed using signal processing techniques. This makes it somewhat difficult to present a direct graphical comparison between the signals at the u-bends. Looking at the same measurements as in figure 9, but in the vicinity of the bend, in figure 10, reveals some such drift but no major change in signal shape:

Our conclusion from observing these measurements and many more from this site was that there was a minimal effect of the u-bend on the internal cross section. Thus we were able to analyze the entire set of measurements without the need to take any special steps to take these bends into account. A full account of holes, pitting and erosions was given to the operator.
